Repairing the drive cone of the Yanmar SD 50

Servicing a slipping clutch

Based on their manual, I have repaired the clutch of S/Y Alytes (Lagoon 400, built November 2010) in April 2015.

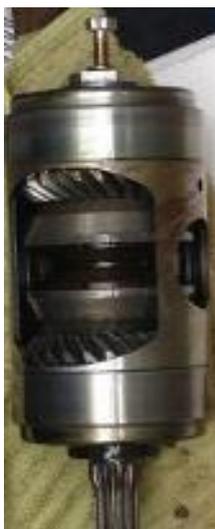
In the picture to the left you see the extracted drive cone assembly. Notice the bolt on the top of the assembly, it is one of the bolts that used to tighten the cap (step 1).

Also note the rather large nut, in which the bolt mentioned above is inserted. This will be important in the next steps and is actually a tricky bit of hardware.

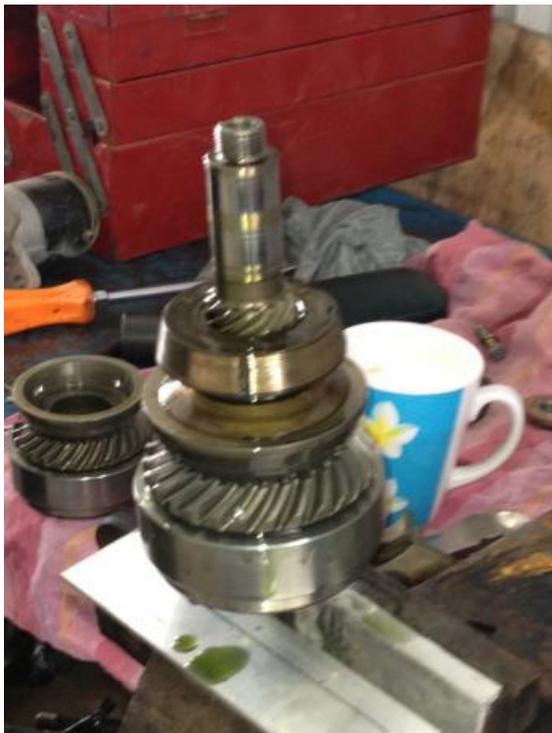
In the absence of the above, both Mark (S/V Isabella) and Fritze (S/V Alytes) used 2 pieces of aluminum section inserted into the vice jaws as shown in the pic....aluminum is softer than the spline...the spline wasn't damaged at all.

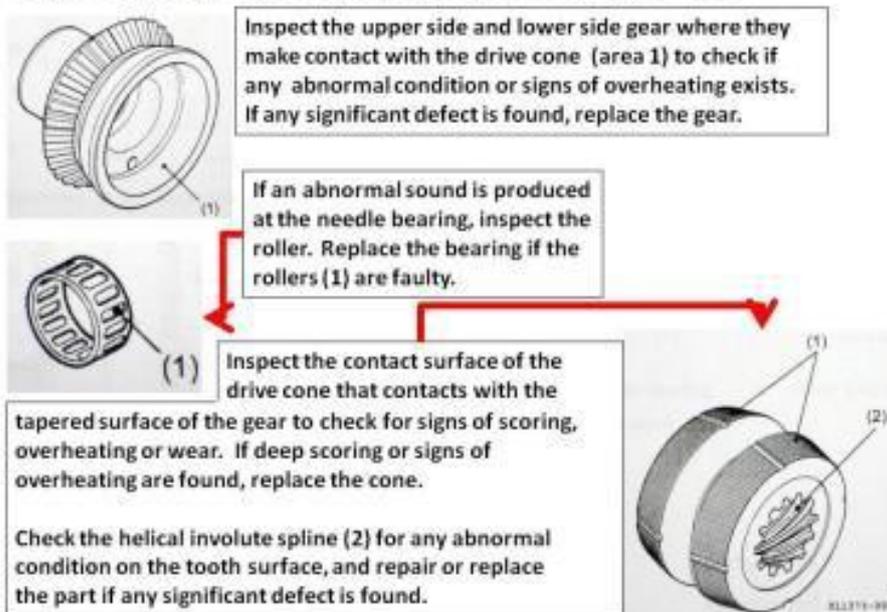
Figure 10: Step 6 Inspecting The Drive Cone And Gear

Once you have disassembled the drive cone assembly, inspect the upper side and lower side gears where they make contact with the drive cone to check if any abnormal condition or signs of overheating exists (see area 1 in the upper left hand picture in Figure 10).

If any significant defect is found, you should consider replacing the gear. Inspect the roller (see the middle picture in Figure 10) and if an abnormal sound is produced at the needle bearing this means the rolls are faulty and the bearing needs to be replaced.

Inspect the surface of the drive cone that contacts with the tapered surface of the gear to check for signs of scoring, overheating or wear (see the bottom right picture in Figure 10).

You will most likely find both the cone and the gears (Area 1 in Figure 10) smooth and glazed. That is your problem, its removal will be addressed in Step 7. But while you're at it, inspect some more:

If deep scoring or signs of overheating are found, replace the cone. Oil is "squeezed" into the horizontal grooves on the cone when it's engaged. If the ridges have been worn flat, then the cone will definitely need replacement.

Check the helical involute spline (2) for any abnormal condition on the tooth surface, and repair or replace the part if any significant defect is found (see the bottom right picture in Figure 10).

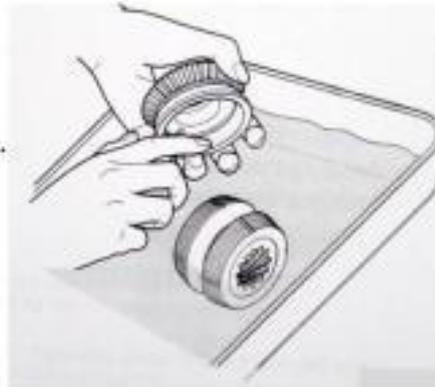
Figure 12: Step 7 Lapping Procedure For Drive Cone, Cont.

When assembling the drive cone, be sure to check its alignment. The larger diameter 044 face should be on the lower gear side.

After lapping them, wash them with kerosene or similar solvent. They need to be washed thoroughly so no grit is present.

When you are finished, make sure that you clean every part of the assembly thoroughly with kerosene, gasoline or a similar solvent. It is of high importance to get all the grit and residue from the lapping out of the assembly.

Also make sure, that you re-insert the cone the right way (Figure 12).
