Repairing the drive cone of the Yanmar SD 50

Servicing a slipping clutch

Based on their manual, I have repaired the clutch of S/Y Alytes (Lagoon 400, built November 2010) in April 2015.

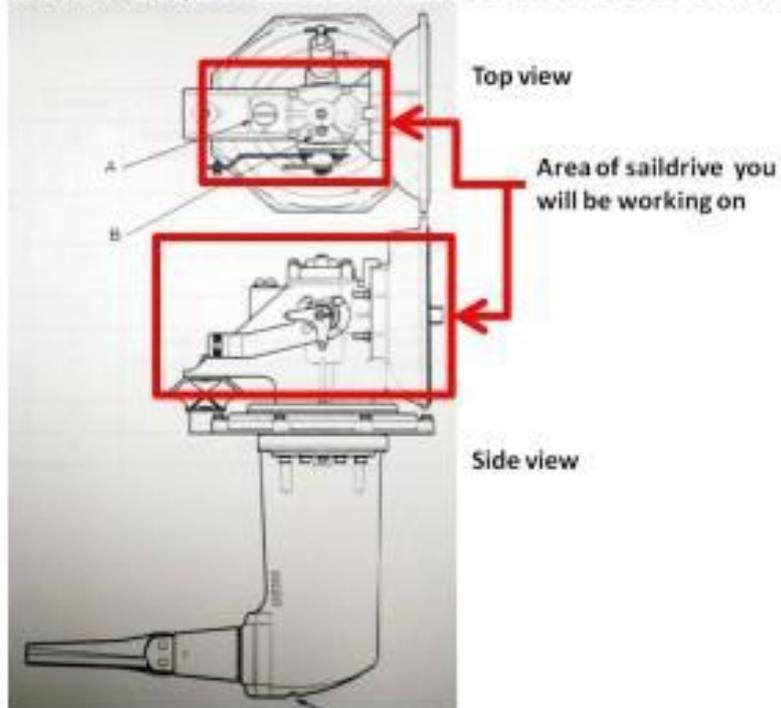
Figure 1: Side And Top View Of Yanmar SD 40 or SD 50 Saildrive

Figure 1 shows the side and top view of the saildrive and highlights the area of the saildrive you will be working on.

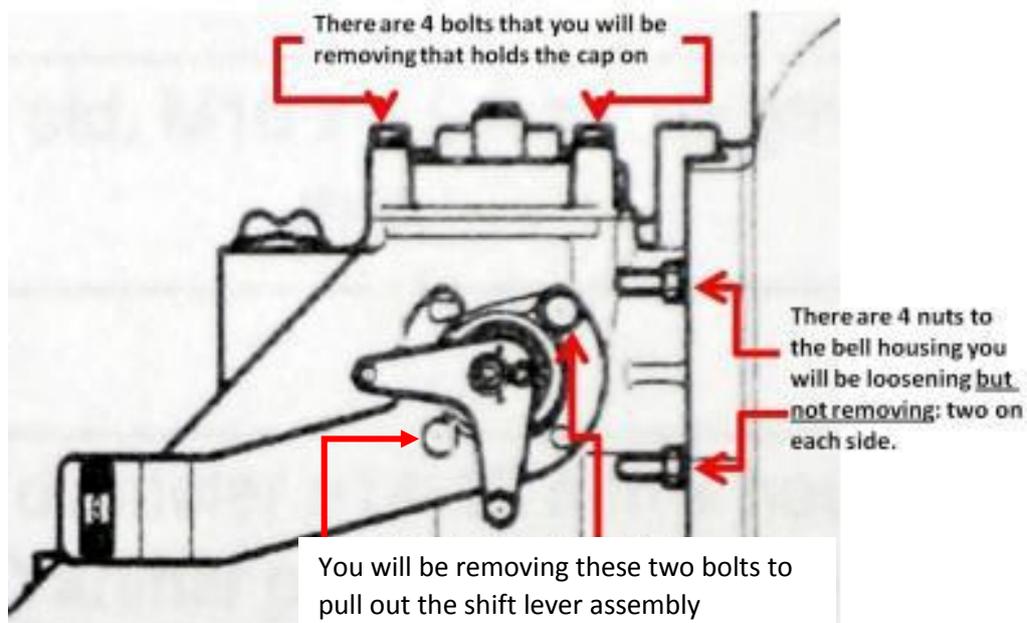
Figure 2: Close-up View Of What You Will Be Working On

Figure 2 is a close up of the area of the saildrive you will be working on. It also shows the bolts and nuts that you will be removing or loosening.

The secret of not having to separate the engine from the saildrive and then moving the engine forward is that you will just be loosening the 4 nuts at the bell housing but not removing them from the stud bolt. You then push those stud bolts forward and it backs the pinion gear and its shaft away from the drive cone assembly and allows you to remove the drive cone assembly.

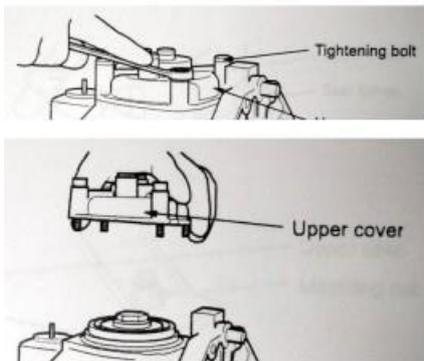
Figure 3: Step 1: Remove Upper Gear Tightening Bolts (4) And Upper Gear Cover

Figure 3 shows the first part of step one. Before actually opening the cap, it is recommended to pump or siphon out about 200 ml of gear oil. Some sailors did this after removing the cap, we drained oil through the dipstick opening before opening the housing. In any case, you do this so that when you remove the shift lever assembly, gear oil will not run out and get things messy.

Using a wrench, loosen and remove the four bolts that secure the upper cover cap.

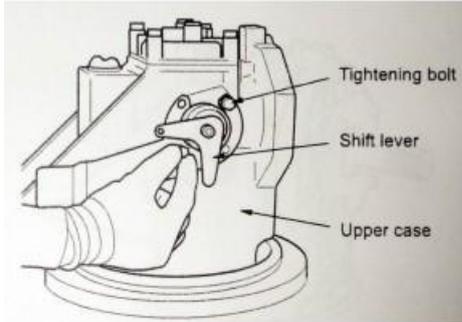
Figure 4: Step 2 Remove Shift Lever Assembly

Figure 4 shows what you will be working on and Figure 5 shows what the shift lever assembly looks like.

Remove the two shift lever tightening bolts

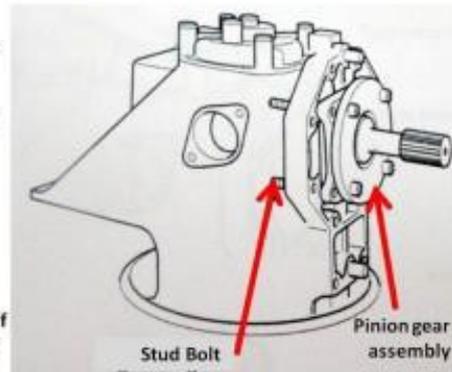
Figure 6: Step 3 Loosen Bell Housing Nuts And Push Pinion Gear And Shaft Back

Figure 6 shows the bell housing removed and exposes the pinion shaft assembly.

You need to only loosen the nut that is on each of the 4 stud bolts and back them off until they are just at the end of each stud bolt. They should be backed in a way that the end of the bolt is slightly (really just barely) recessed in the nut. So the nut protects the bolt's threading in the next step.

Next, using a hammer, gently tap each nut/bolt to move the pinion gear assembly back a bit so you can easily remove the drive cone assembly. Do not hit the bolts with a hammer directly, as this would damage the threads.

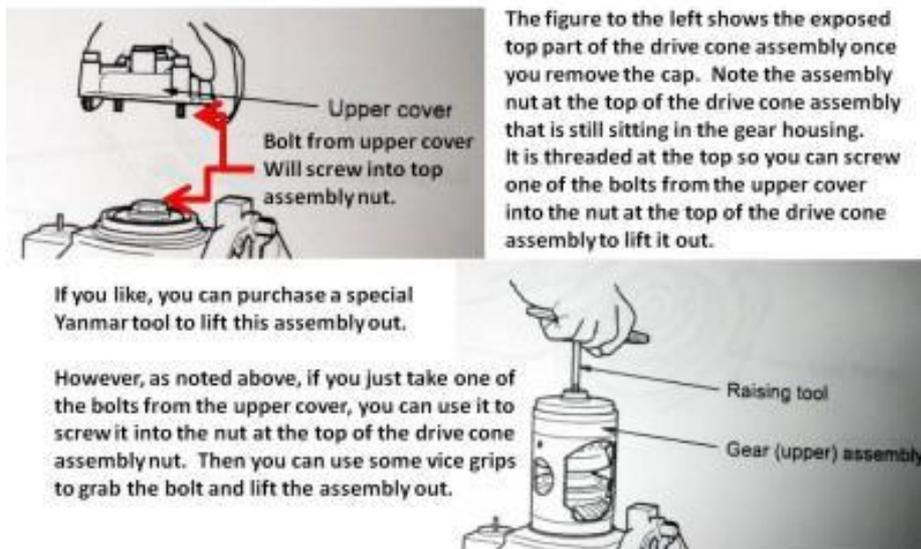
Figure 7: Step 4 Remove The Drive Cone Assembly

Figure 7 shows the exposed top part of the drive cone assembly once you remove the upper gear casing cover cap.

Note the nut at the top of the drive cone assembly which is still sitting in the gear housing in this picture. It is threaded at the top. If you like, you can go ahead and buy Yanmar's special extraction tool, however, if you are clever, it really is not needed. Instead, just take one of the four bolts that you removed from the upper gear casing cover cap (see Step 1). As it turns out, it has the identical threading as the drive cone assembly's top nut. Thus, all you need to do is screw in one of those bolts, grab it with a pair of vice grips or pliers and lift the drive cone assembly out.

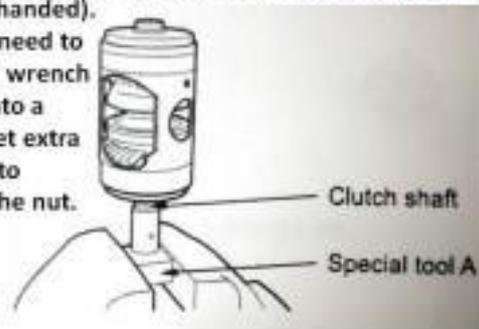
The best way would be to insert the clutch shaft into a spline socket so you can insert the socket into the vice without damaging the splines on the shaft.

In the absence of the above, both Mark (S/V Isabella) and Fritze (S/V Alytes) used 2 pieces of aluminum section inserted into the vice jaws as shown in the pic....aluminum is softer than the spline...the spline wasn't damaged at all.

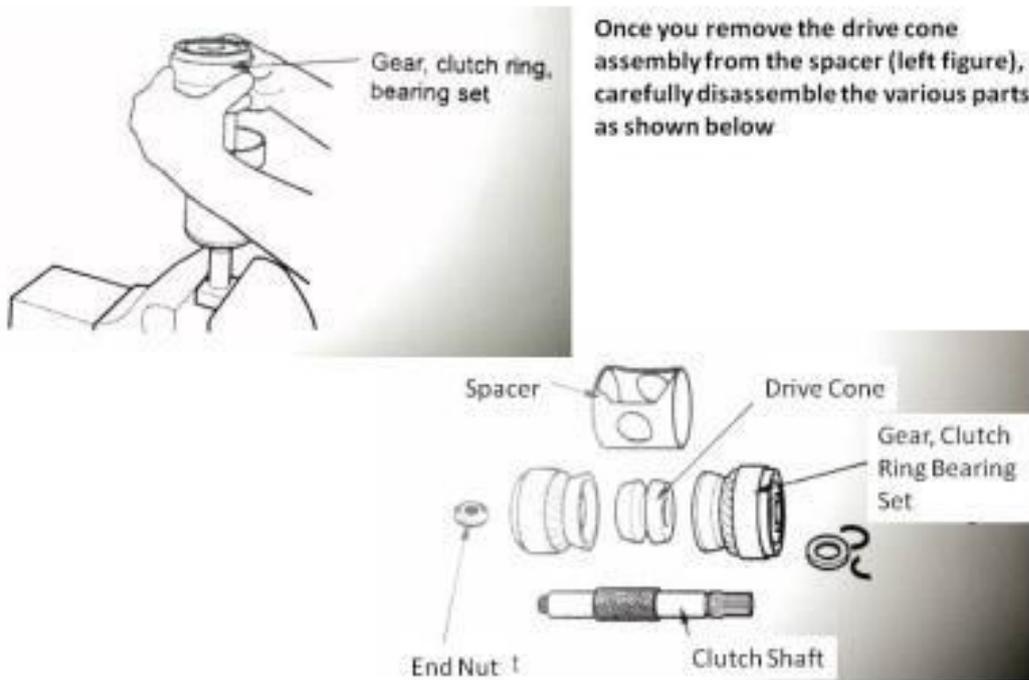
Figure 9: Step 5 Disassembling The Drive Cone Assembly, Con't.

With the nut off, you can slip off the spacer and disassemble the assembly (see Figure 9).

NOW ITS TIME TO GO SLOW!!! Make sure you use a system to layout the parts in some sort of order. We used a scribing tool to mark the "top" of the 3 gears and cone.
